Exterior Architectural Finishes in Puerto Rico: The Painting Traditions of Guayama's Vernacular Architecture

Betty L. Prime
University of Pennsylvania

Prime, Betty L., "Exterior Architectural Finishes in Puerto Rico: The Painting Traditions of Guayama's Vernacular Architecture" (2011). *Theses (Historic Preservation)*. 164.
http://repository.upenn.edu/hp_theses/164

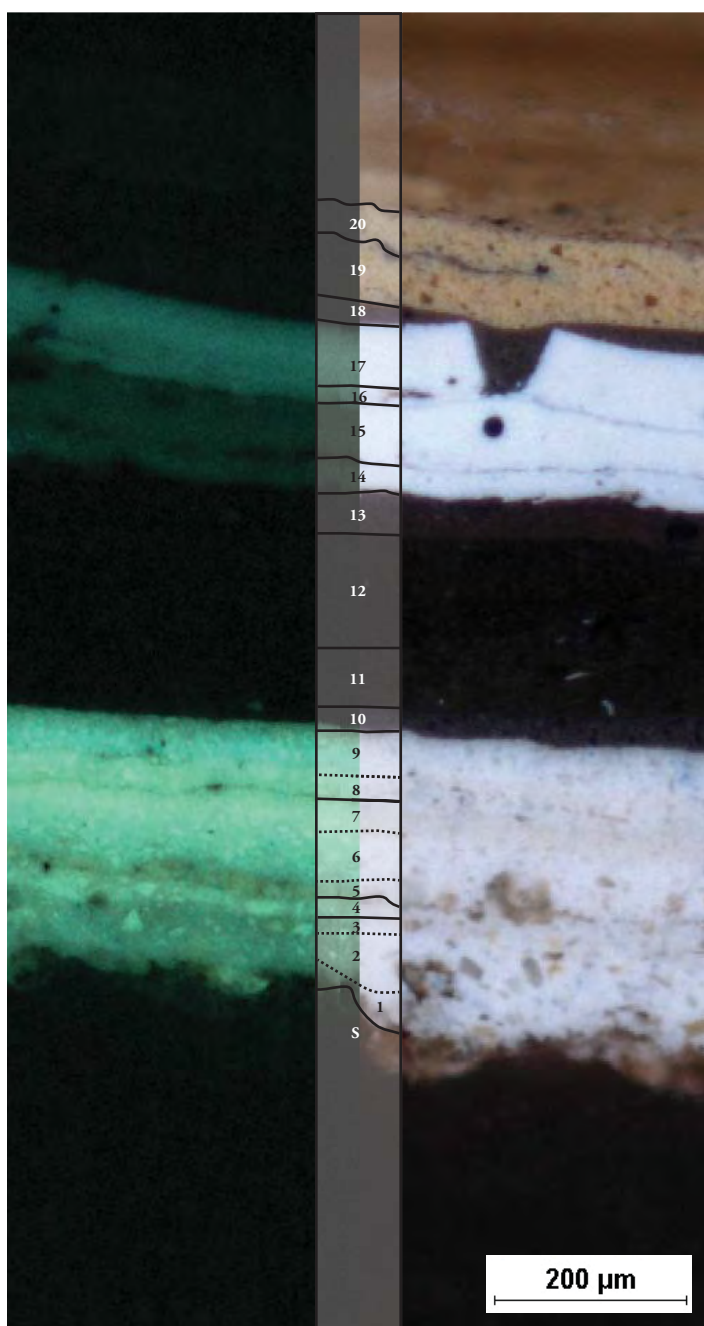
Sample Number: 43 :D: 1	Element: porch railing	Date Sampled: 02/13/11
Sample Location: middle		Date Analyzed: 03/27/11
Substrate: wood	Illumination: Fluorescence BV 1A, Reflected/Quartz Halogen	
Microscope: Nikon ALPHAPHOT2-YS2		Objective: 4x
Analysis Performed by: Betty Prime		Camera: Nikon DS-Fi1

Scheme/Layer		Color
15	20	orange yellow
14	19	*orange yellow
13	18	dark brown
12	17	white
11	16	white
10	15	*white
9	14	*white
8	13	red brown
7	12	dark brown
6	11	green brown
5	10	dark grey
4	9	blue white
	8	blue white
	7	off white
3	6	off white
	5	off white
2	4	*off white
	3	*off white
1	2	white
	1	white
		substrate

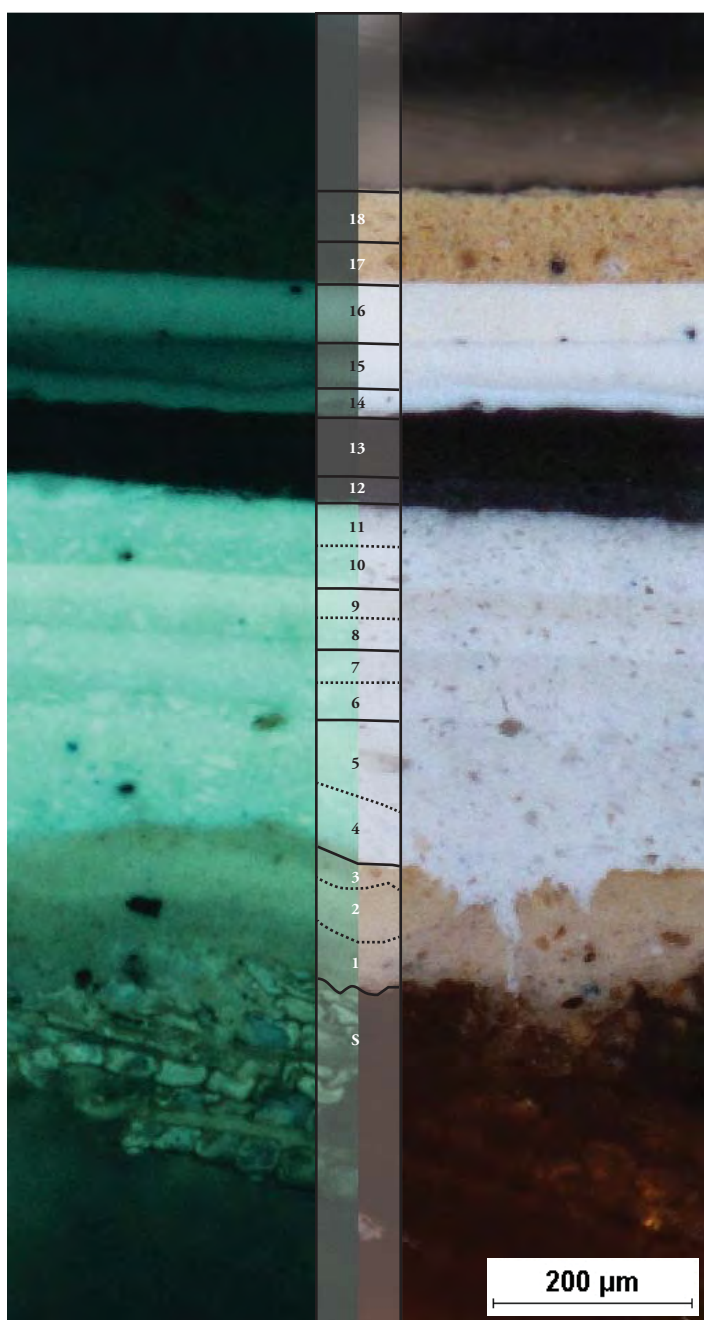
Sample Number: 43 :D: 2	Element: porch railing	Date Sampled: 02/13/11
Sample Location: balustrade		Date Analyzed: 03/27/11
Substrate: wood	Illumination: Fluorescence BV 1A, Reflected/Quartz Halogen	
Microscope: Nikon ALPHAPHOT2-YS2		Objective: 4x
Analysis Performed by: Betty Prime		Camera: Nikon DS-Fi1

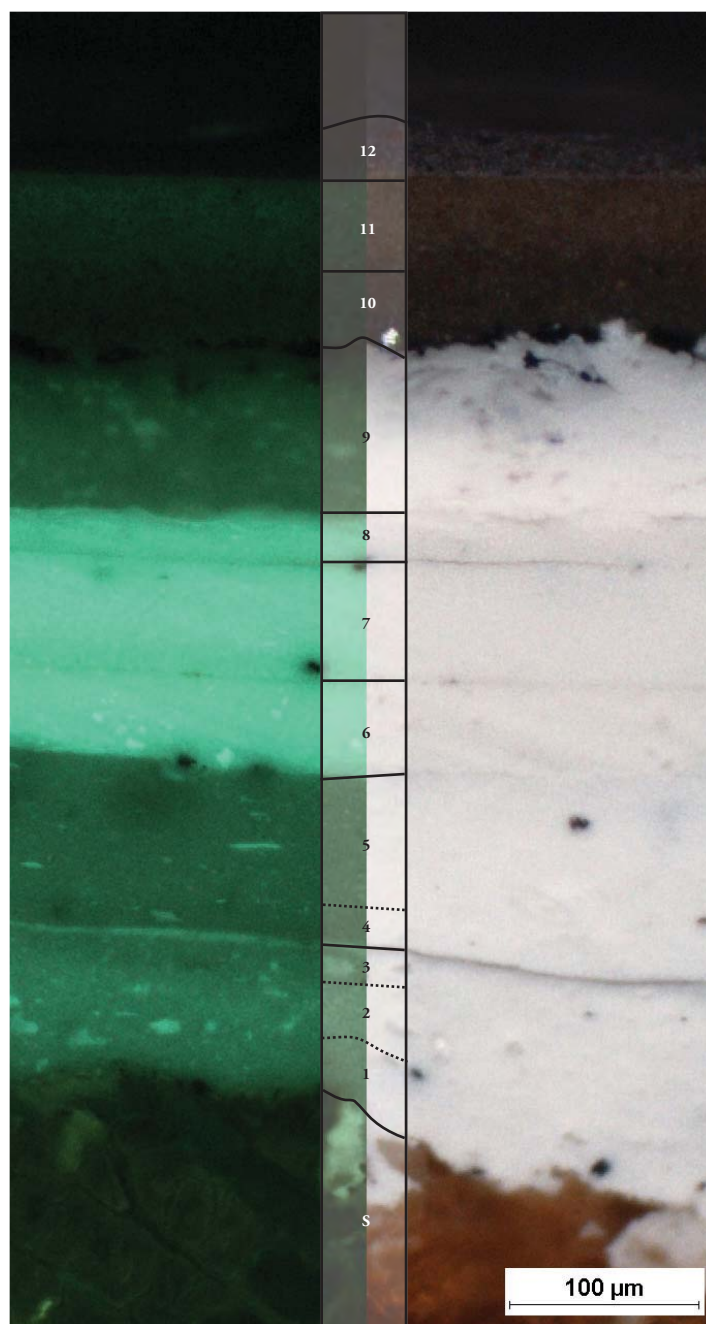
Sample Number: 43 E: 1	Element: porch handrail	Date Sampled: 02/13/11
Sample Location: top		Date Analyzed: 03/27/11
Substrate: wood	Illumination: Fluorescence BV 1A, Reflected/Quartz Halogen	
Microscope: Nikon ALPHAPHOT2-YS2		Objective: 10x
Analysis Performed by: Betty Prime		Camera: Nikon DS-Fi1

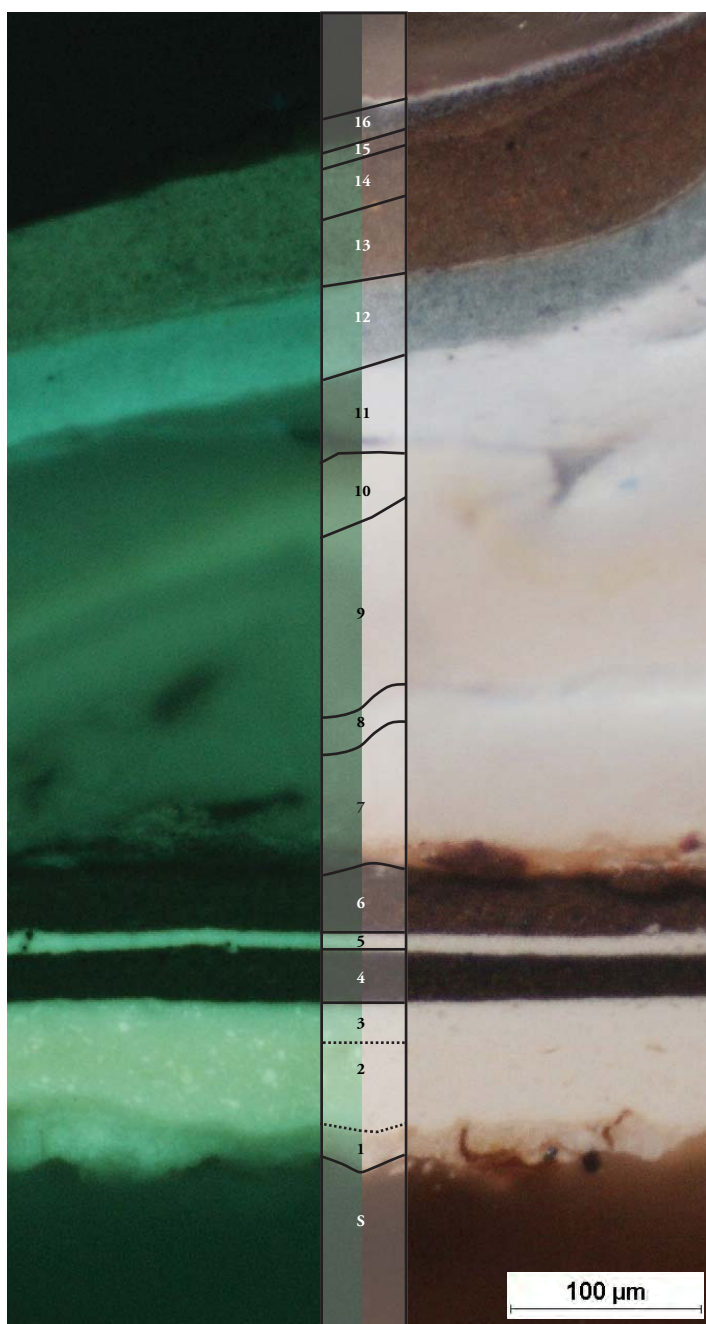
Sample Number: 43 G: 2	Element: door frame	Date Sampled: 02/13/11
Sample Location:		Date Analyzed: 03/27/11
Substrate: wood	Illumination: Fluorescence BV 1A, Reflected/Quartz Halogen	
Microscope: Nikon ALPHAPHOT2-YS2		Objective: 10x
Analysis Performed by: Betty Prime		Camera: Nikon DS-Fi1

Scheme/Layer		Color
13	16	blue grey
12	15	dark brown
11	14	dark brown
10	13	dark brown
9	12	blue
8	11	light blue
7	10	light yellow
6	9	cream
5	8	light blue
4	7	cream
3	6	red brown
	5	off white
2	4	dark red brown
	3	off white
1	2	off white
	1	light tan
		substrate

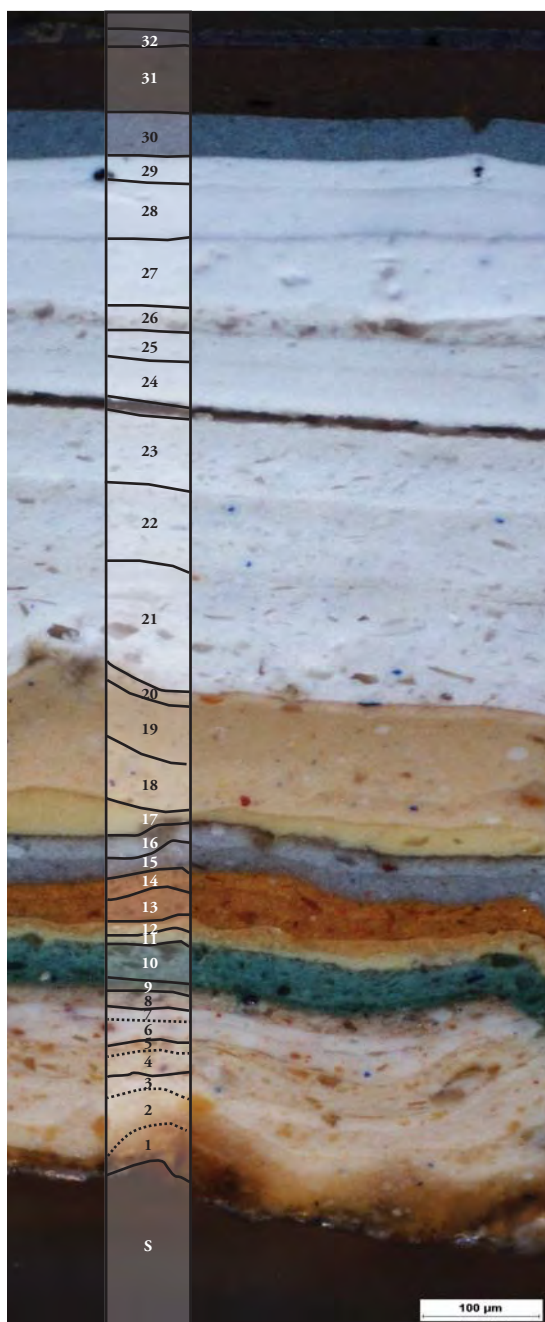
Sample Number: 43 :F: 1	Element: door	Date Sampled: 02/13/11
Sample Location: north door		Date Analyzed: 03/27/11
Substrate: wood	Illumination: Reflected/Quartz Halogen	
Microscope: Nikon ALPHAPHOT2-YS2		Objective: 10x
Analysis Performed by: Betty Prime		Camera: Nikon DS-Fi1

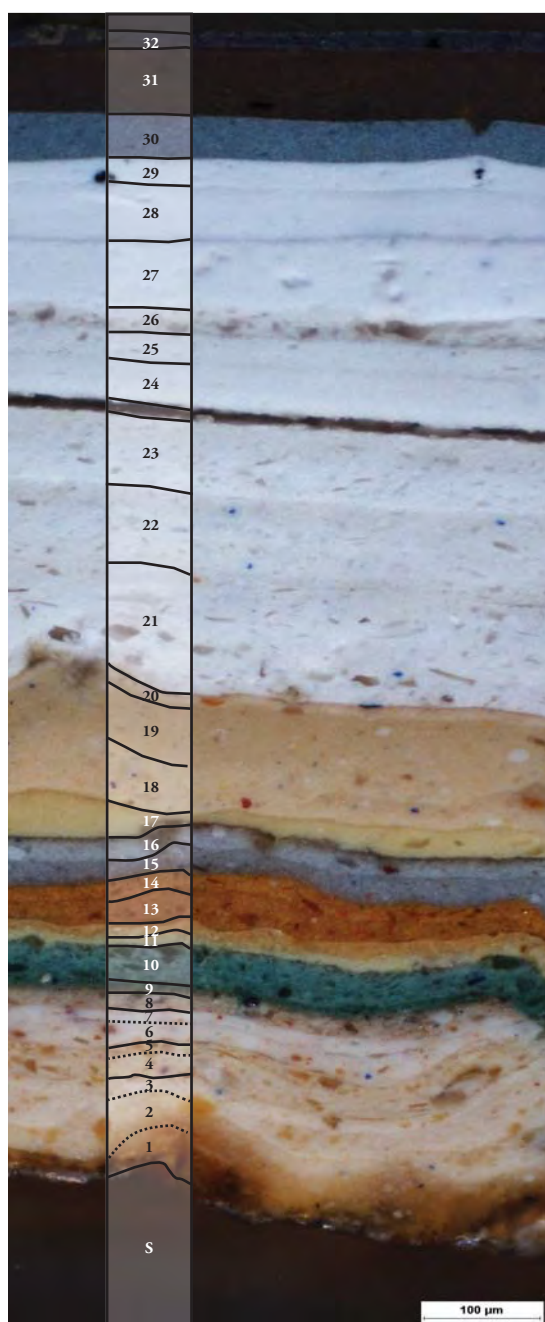
Sample Number: 43 :F: 1	Element: door	Date Sampled: 02/13/11
Sample Location: north door		Date Analyzed: 03/27/11
Substrate: wood	Illumination: Reflected/Quartz Halogen	
Microscope: Nikon ALPHAPHOT2-YS2		Objective: 10x
Analysis Performed by: Betty Prime		Camera: Nikon DS-Fi1

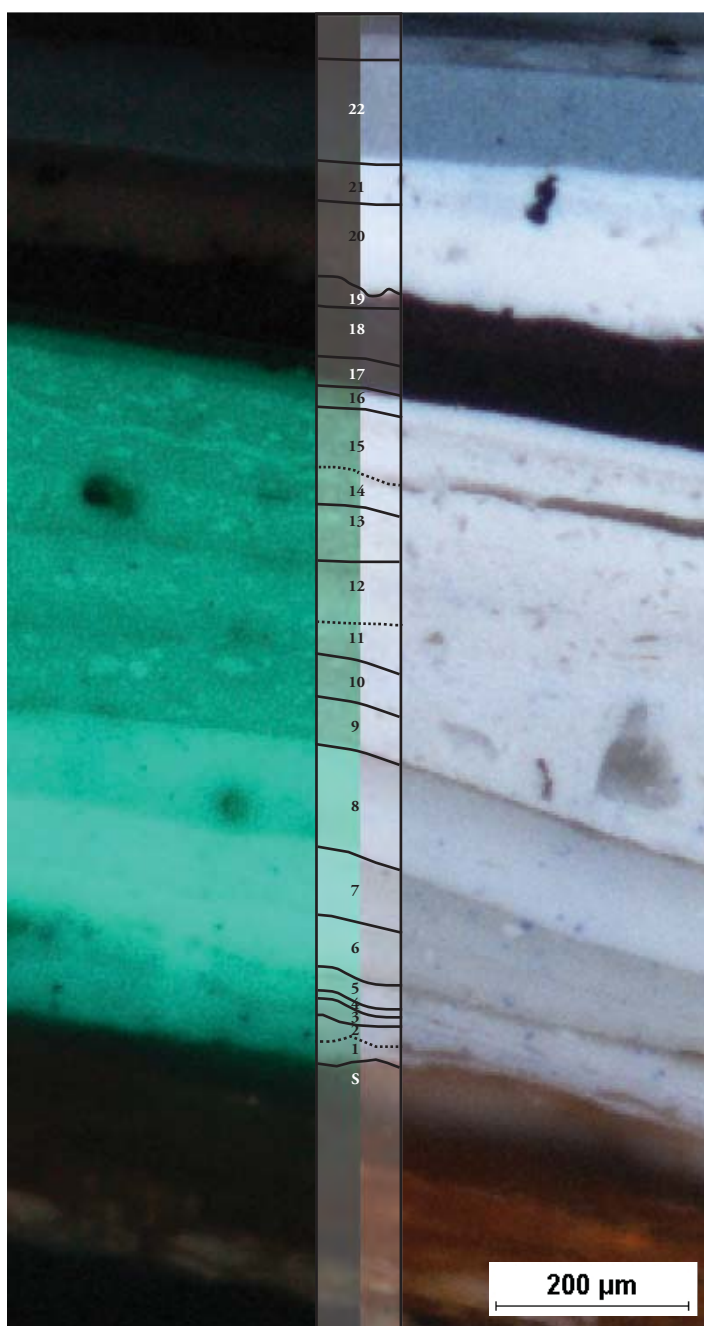
Sample Number: 43 :H:5	Element: cornice/soffit	Date Sampled: 02/13/11
Sample Location: underside board, soffit		Date Analyzed: 03/27/11
Substrate: wood	Illumination: Fluorescence BV 1A, Reflected/Quartz Halogen	
Microscope: Nikon ALPHAPHOT2-YS2		Objective: 4x
Analysis Performed by: Betty Prime		Camera: Nikon DS-Fi1

Scheme/Layer		Color
19	22	blue grey
18	21	white
17	20	white
16	19	red brown
15	18	dark brown
14	17	green brown
13	16	white
12	15	off white
11	14	/off white
	13	off white
10	12	off white
9	11	off white
	10	off white
8	9	off white
7	8	blue white
6	7	blue white
5	6	blue white
4	5	blue white
3	4	blue white
2	3	blue white
1	2	blue white
	1	blue white
		substrate

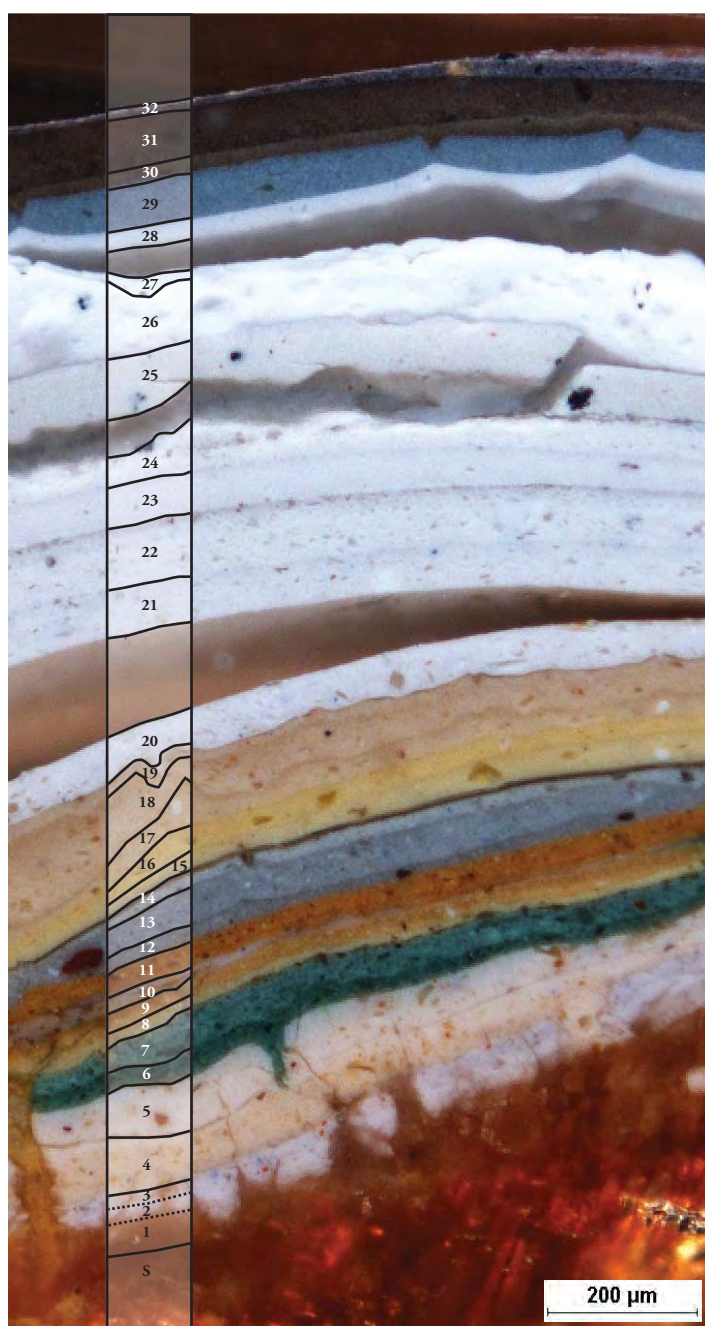
Sample Number: 43 :K:1	Element: window shutter	Date Sampled: 02/13/11
Sample Location: left edge, 2nd window from north		Date Analyzed: 03/27/11
Substrate: wood	Illumination: Reflected/Quartz Halogen	
Microscope: Nikon ALPHAPHOT2-YS2		Objective: 4x
Analysis Performed by: Betty Prime		Camera: Nikon DS-Fi1

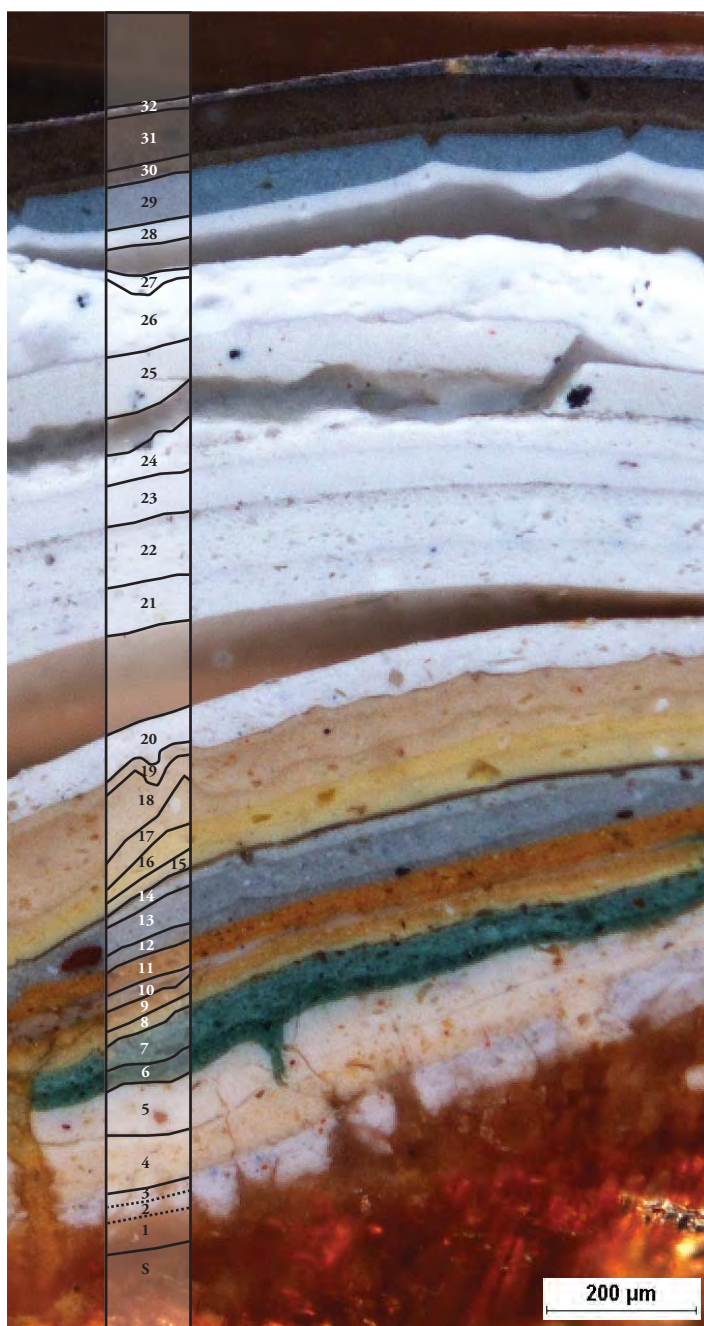
Sample Number: 43 :K:1	Element: window shutter	Date Sampled: 02/13/11
Sample Location: left edge, 2nd window from north		Date Analyzed: 03/27/11
Substrate: wood	Illumination: Reflected/Quartz Halogen	
Microscope: Nikon ALPHAPHOT2-YS2		Objective: 4x
Analysis Performed by: Betty Prime		Camera: Nikon DS-Fi1

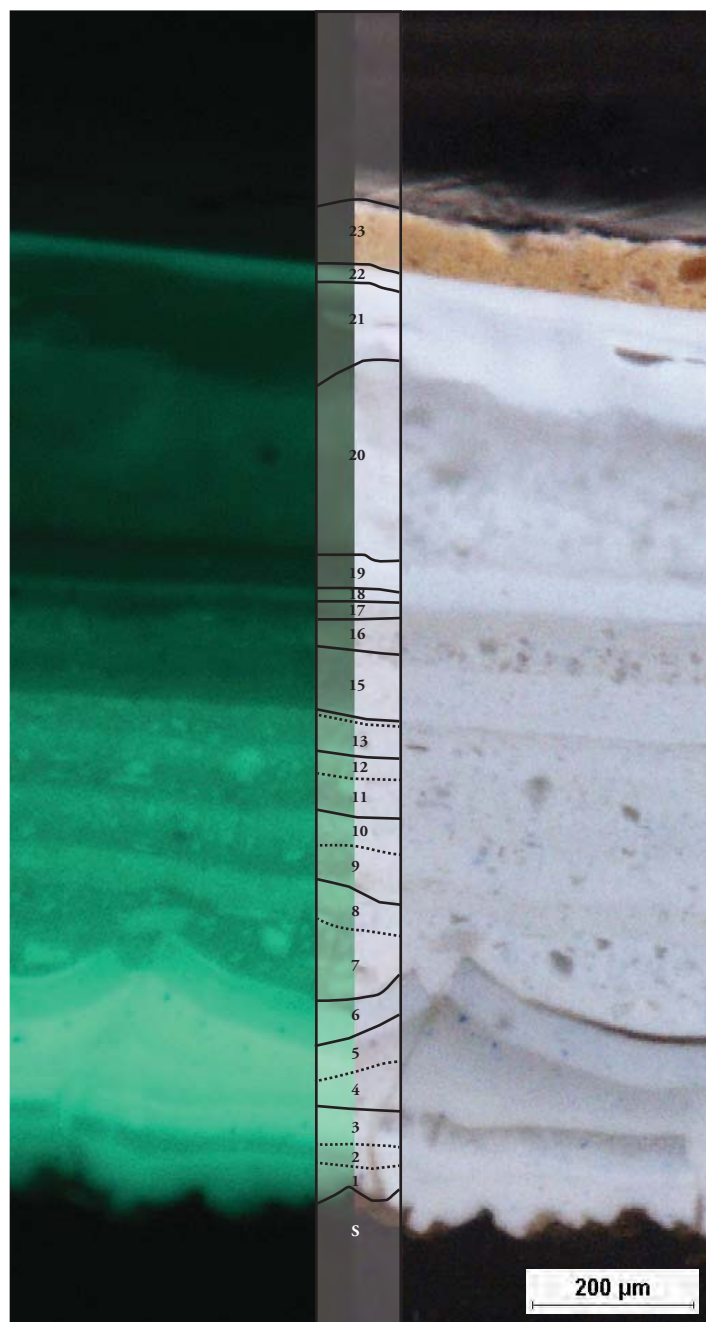
Sample Number: 43 :L: 1	Element: ceiling	Date Sampled: 02/13/11
Sample Location: ceiling #2		Date Analyzed: 03/27/11
Substrate: wood	Illumination: Fluorescence BV 1A, Reflected/Quartz Halogen	
Microscope: Nikon ALPHAPHOT2-YS2		Objective: 4x
Analysis Performed by: Betty Prime		Camera: Nikon DS-Fi1

Scheme/Layer		Color
16	23	orange yellow
15	22	white
14	21	white
13	20	off white
12	19	white
11	18	white
10	17	*cream
9	16	cream
8	15	off white
7	14	*off white
	13	off white
6	12	off white
	11	off white
5	10	off white
	9	off white
4	8	off white
	7	off white
3	6	/blue white
2	5	blue white
	4	blue white
1	3	blue white
	2	blue white
	1	white
		substrate

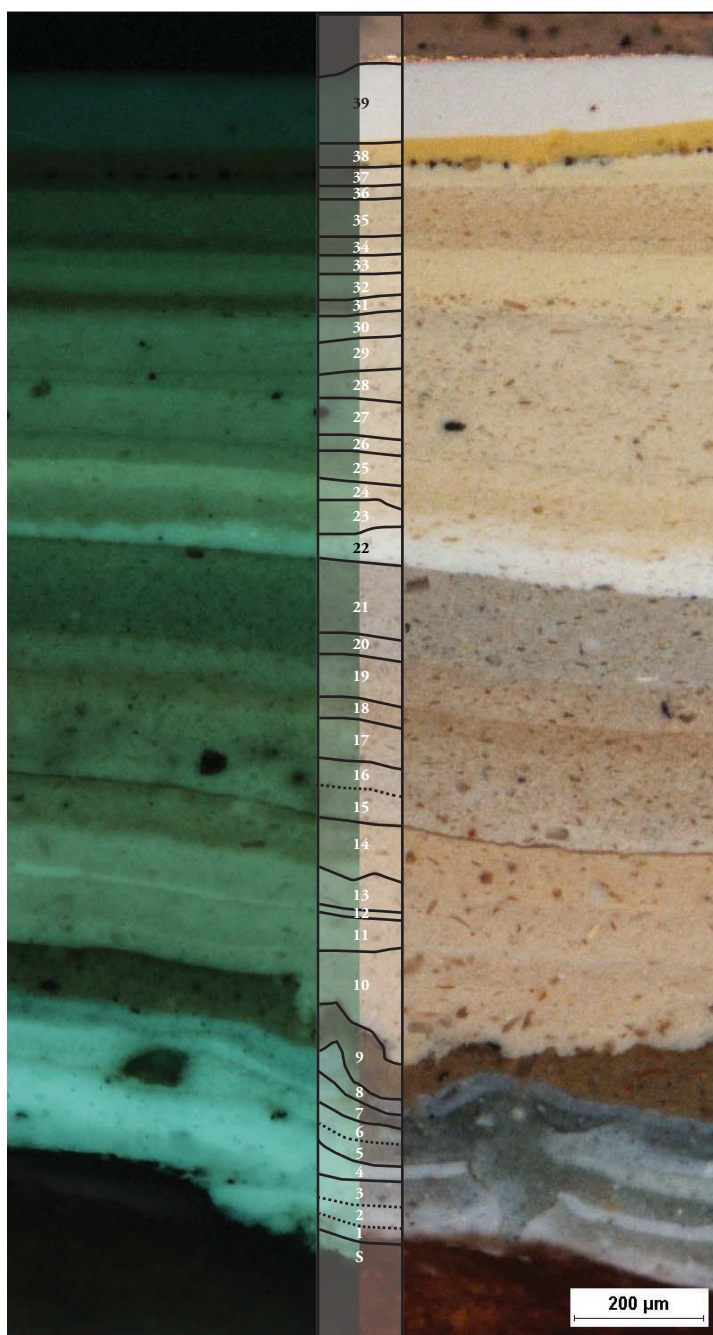
Sample Number: 3 :A: 2	Element: wall	Date Sampled: 02/12/11
Sample Location: siding next to south door		Date Analyzed: 04/06/11
Substrate: wood	Illumination: Fluorescence BV 1A, Reflected/Quartz Halogen	
Microscope: Nikon ALPHAPHOT2-YS2		Objective: 4x
Analysis Performed by: Betty Prime		Camera: Nikon DS-Fi1

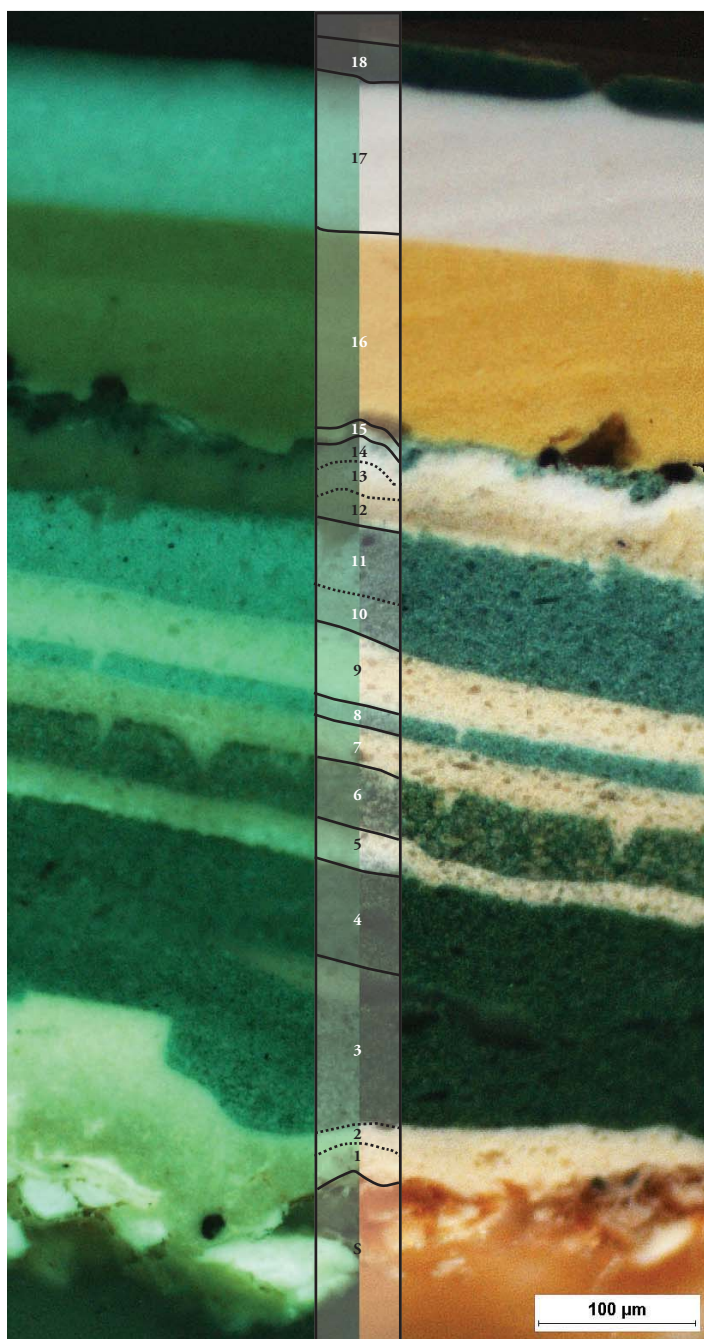
Sample Number: 3 :A: 3	Element: wall	Date Sampled: 02/12/11
Sample Location: baseboard		Date Analyzed: 04/06/11
Substrate: wood	Illumination: Fluorescence BV 1A, Reflected/Quartz Halogen	
Microscope: Nikon ALPHAPHOT2-YS2		Objective: 10x
Analysis Performed by: Betty Prime		Camera: Nikon DS-Fi1

Scheme/Layer		Color
13	18	dark green
12	17	white
11	16	yellow
10	15	/*green
9	14	white
	13	cream
	12	dark cream
8	11	blue green
	10	blue green
7	9	cream
6	8	blue green
5	7	cream
4	6	dark green
3	5	cream
2	4	dark green
1	3	/dark green
	2	cream
	1	cream
		substrate

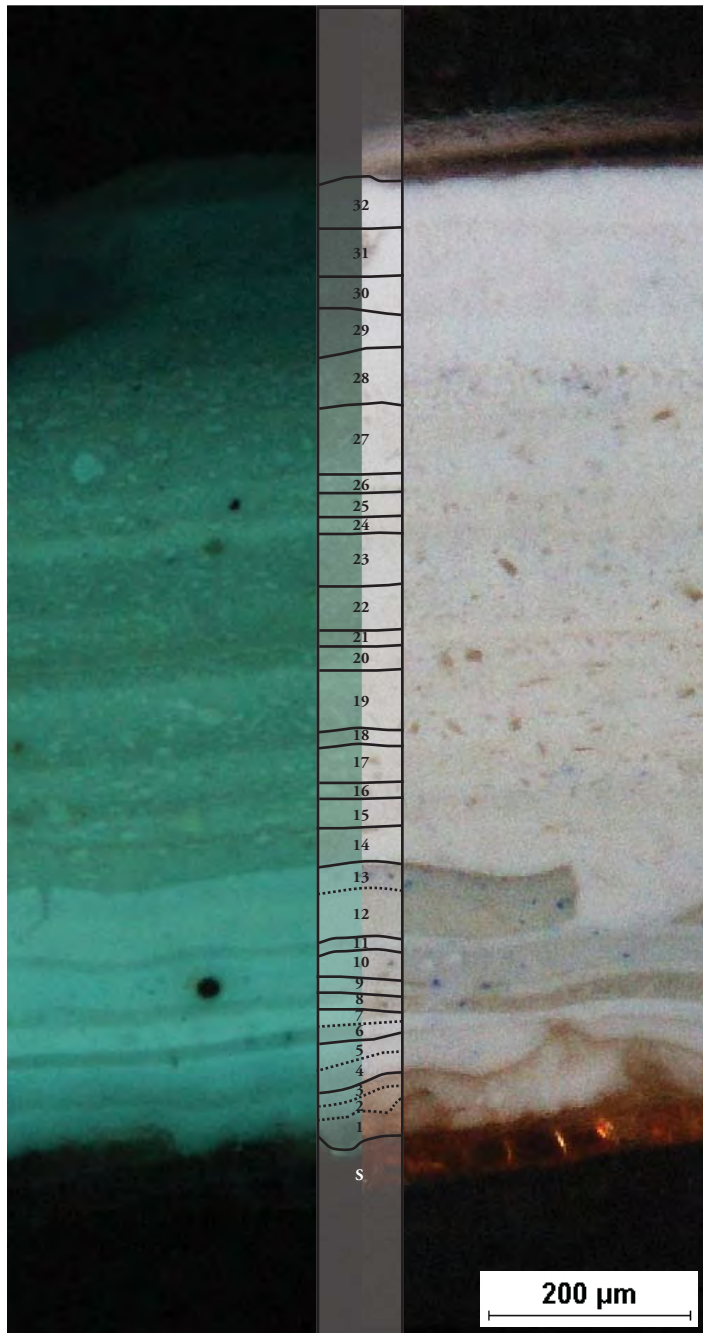
Sample Number: 3 :A: 7	Element: wall	Date Sampled: 02/12/11
Sample Location: crown moulding above south door		Date Analyzed: 04/06/11
Substrate: wood	Illumination: Fluorescence BV 1A, Reflected/Quartz Halogen	
Microscope: Nikon ALPHAPHOT2-YS2		Objective: 4x
Analysis Performed by: Betty Prime		Camera: Nikon DS-Fi1

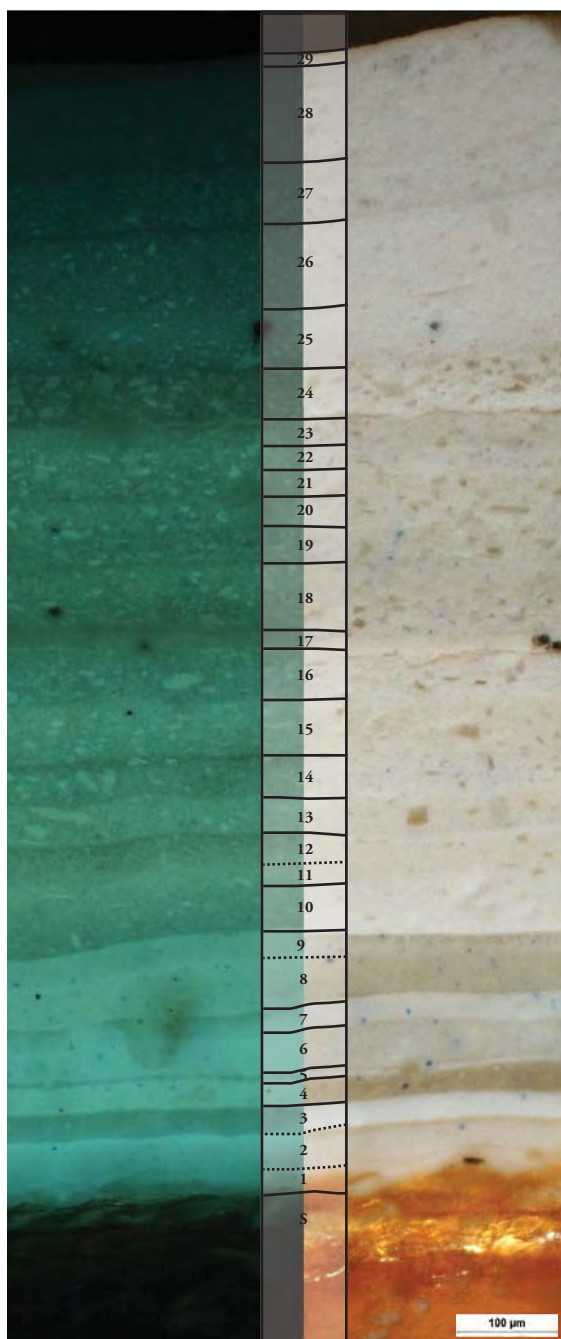
Sample Number: 3 :A: 5	Element: wall	Date Sampled: 02/12/11
Sample Location: moulding diamond pattern, above south door		Date Analyzed: 04/06/11
Substrate: wood	Illumination: Fluorescence BV 1A, Reflected/Quartz Halogen	
Microscope: Nikon ALPHAPHOT2-YS2		Objective: 10x
Analysis Performed by: Betty Prime		Camera: Nikon DS-Fi1

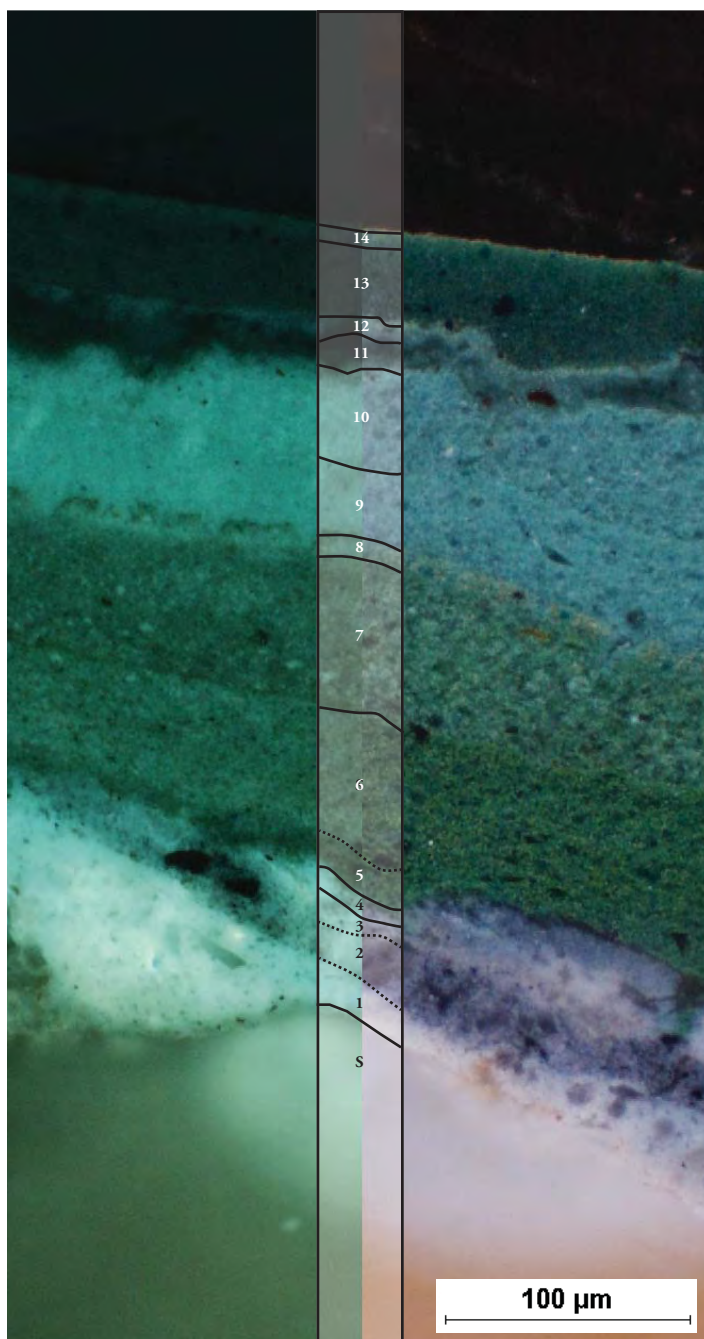
Sample Number: 3 :B: 1	Element: building base	Date Sampled: 02/12/11
Sample Location: far south bay		Date Analyzed: 04/06/11
Substrate: wood	Illumination: Fluorescence BV 1A, Reflected/Quartz Halogen	
Microscope: Nikon ALPHAPHOT2-YS2		Objective: 10x
Analysis Performed by: Betty Prime		Camera: Nikon DS-Fi1

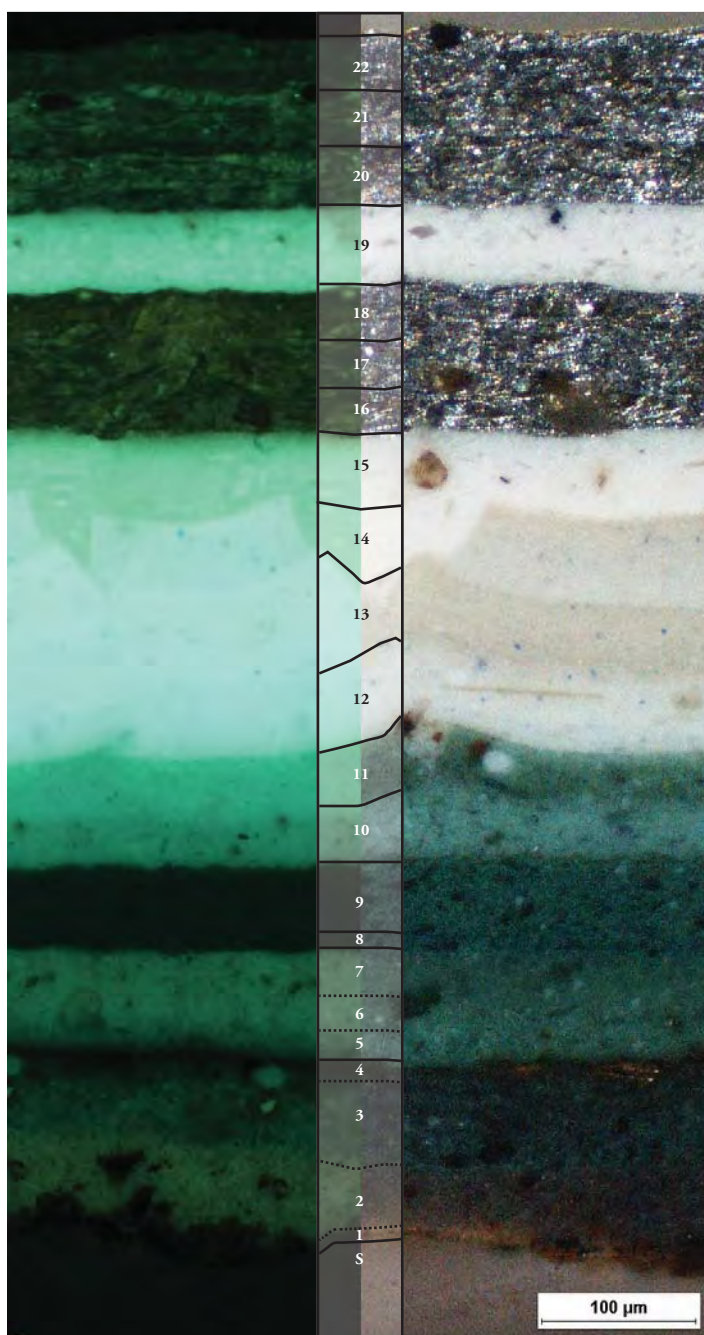
Sample Number: 3 :C: 3	Element: column	Date Sampled: 02/12/11
Sample Location: #2 from south, top		Date Analyzed: 04/06/11
Substrate: iron	Illumination: Fluorescence BV 1A, Reflected/Quartz Halogen	
Microscope: Nikon ALPHAPHOT2-YS2		Objective: 10x
Analysis Performed by: Betty Prime		Camera: Nikon DS-Fi1

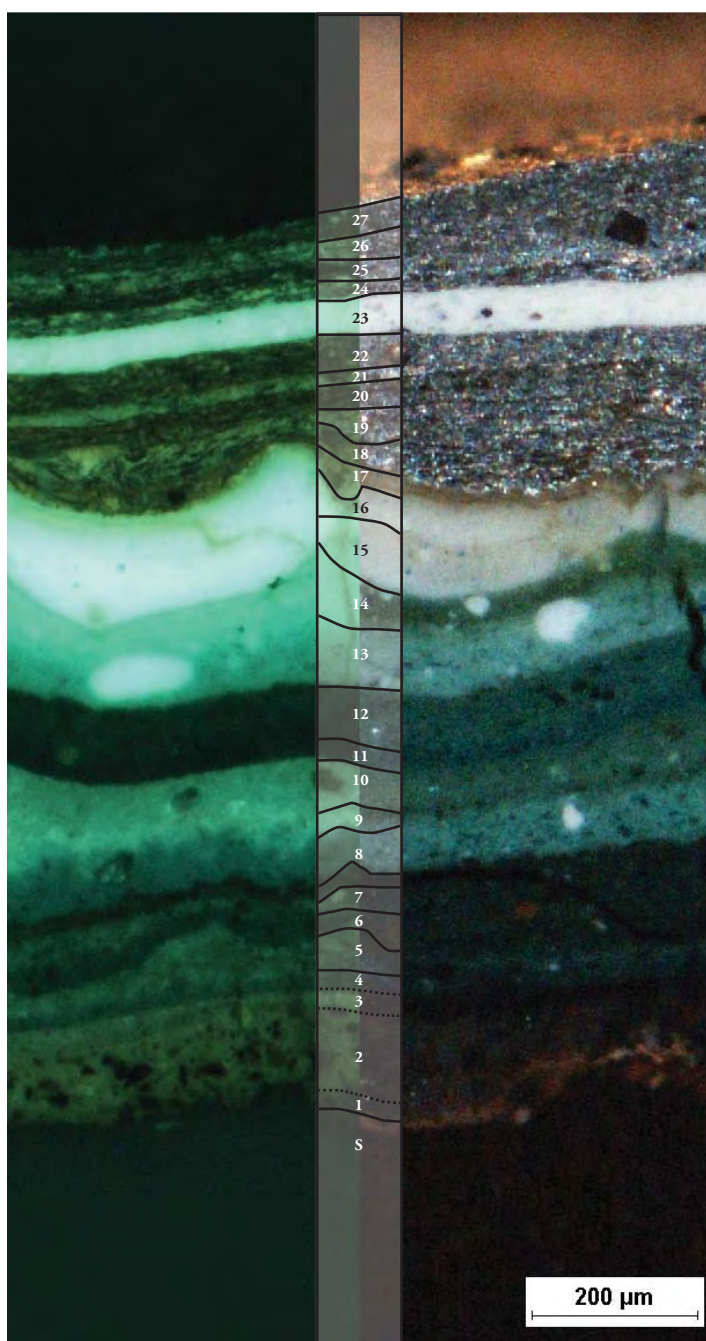
Sample Number: 3 :C: 1	Element: column	Date Sampled: 02/12/11
Sample Location: #2 from the south, middle detail of joint		Date Analyzed: 04/06/11
Substrate: wood	Illumination: Fluorescence BV 1A, Reflected/Quartz Halogen	
Microscope: Nikon ALPHAPHOT2-YS2		Objective: 4x
Analysis Performed by: Betty Prime		Camera: Nikon DS-Fi1

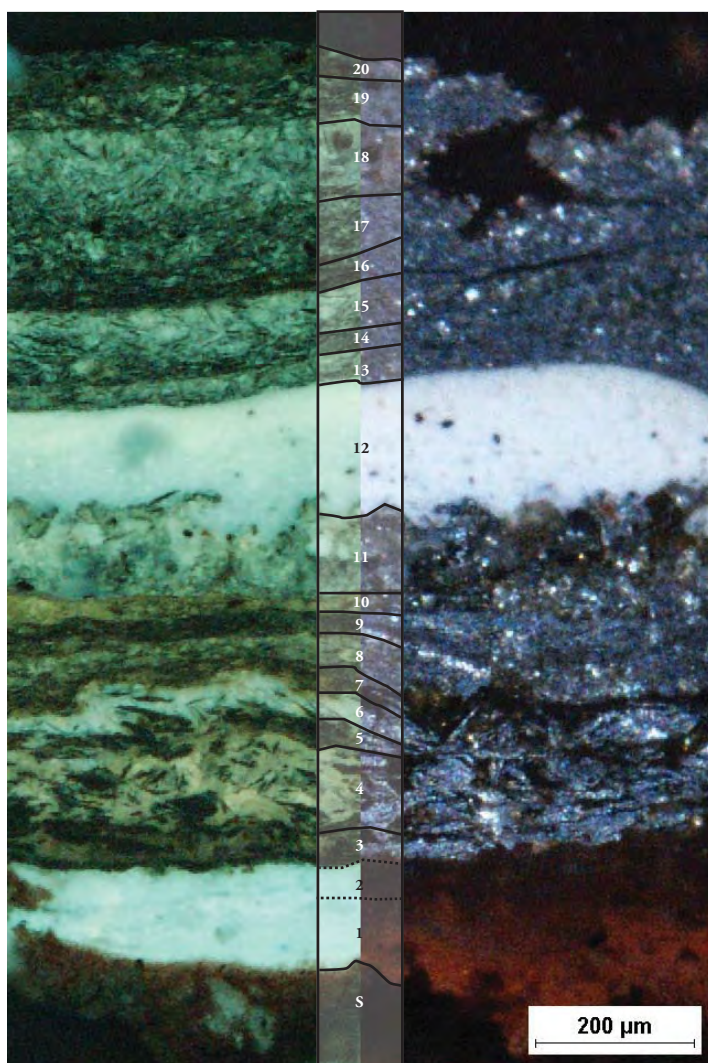
Sample Number: 3 :D: 1	Element: porch railing	Date Sampled: 02/12/11
Sample Location: middle		Date Analyzed: 04/06/11
Substrate: wood	Illumination: Fluorescence BV 1A, Reflected/Quartz Halogen	
Microscope: Nikon ALPHAPHOT2-YS2		Objective: 4x
Analysis Performed by: Betty Prime		Camera: Nikon DS-Fi1

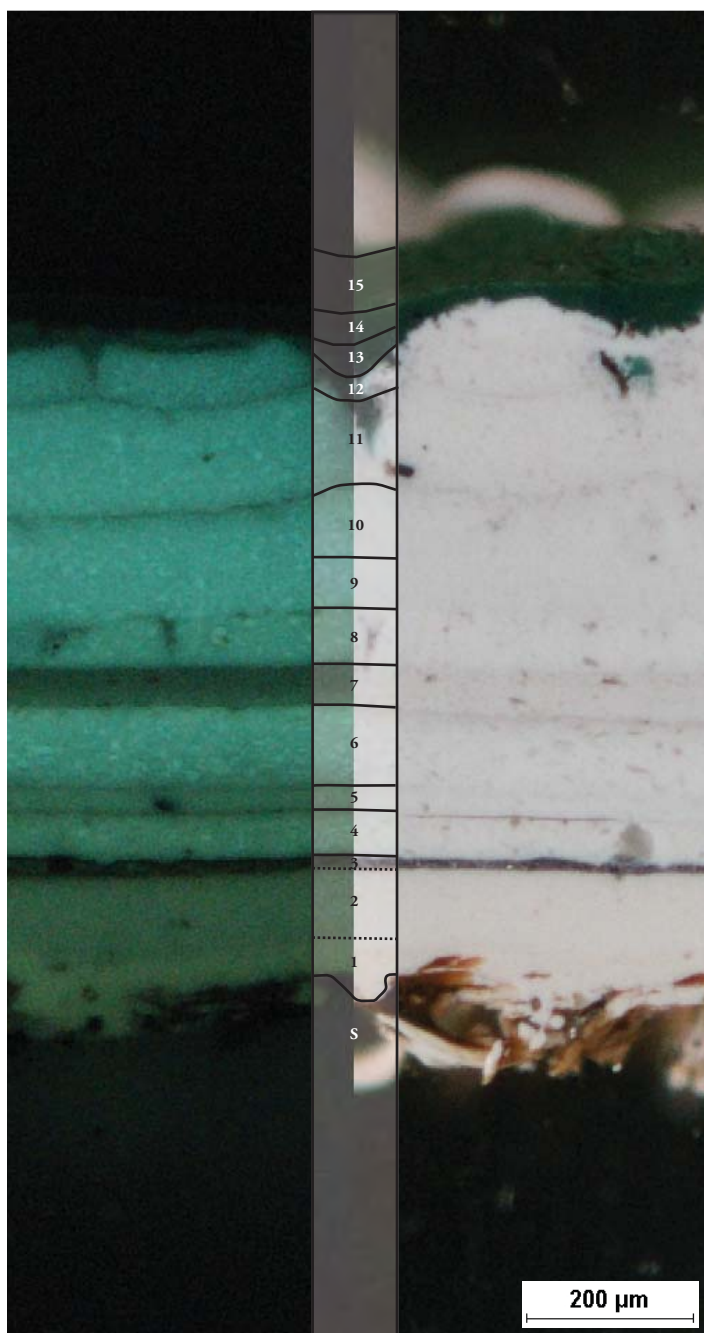
Sample Number: 3 :E: 1	Element: porch handrail	Date Sampled: 02/12/11
Sample Location: #3 from north		Date Analyzed: 04/06/11
Substrate: wood	Illumination: Fluorescence BV 1A, Reflected/Quartz Halogen	
Microscope: Nikon ALPHAPHOT2-YS2		Objective: 4x
Analysis Performed by: Betty Prime		Camera: Nikon DS-Fi1

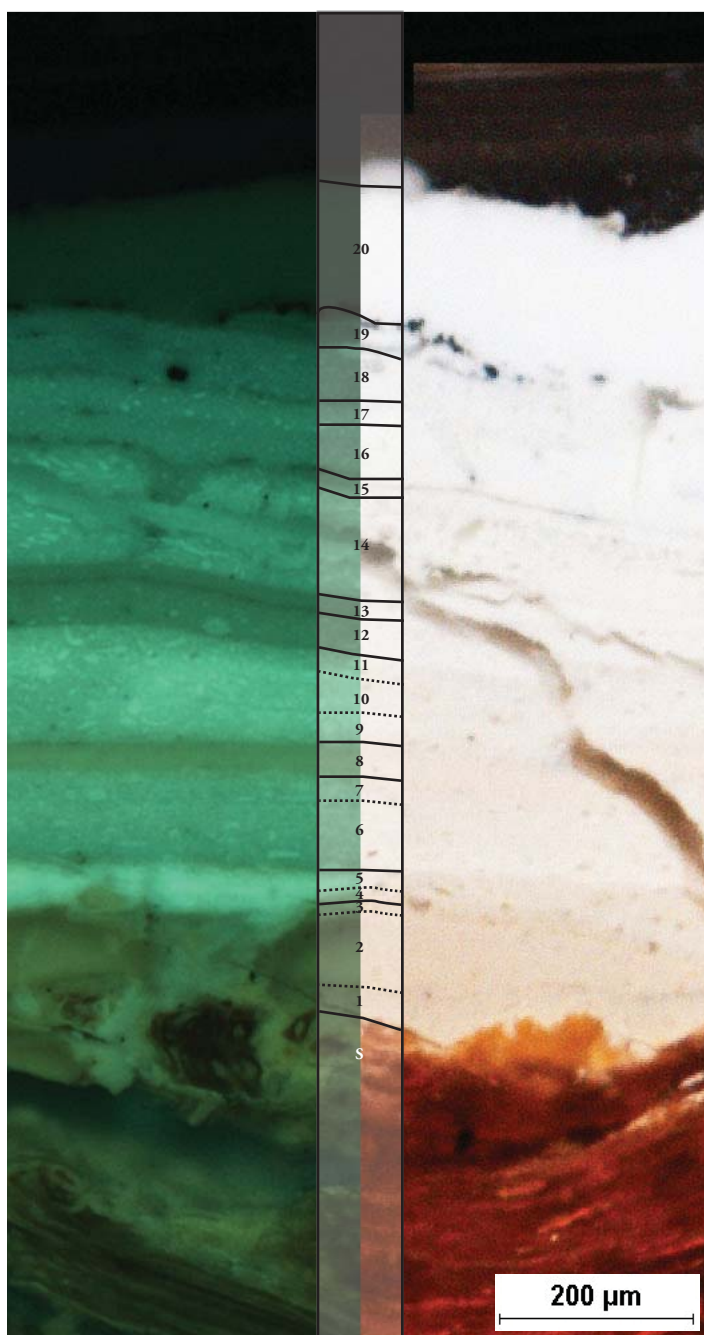
Sample Number: 3 :F: 5	Element: door	Date Sampled: 02/12/11
Sample Location: panel middle frame		Date Analyzed: 04/06/11
Substrate: wood	Illumination: Fluorescence BV 1A, Reflected/Quartz Halogen	
Microscope: Nikon ALPHAPHOT2-YS2		Objective: 4x
Analysis Performed by: Betty Prime		Camera: Nikon DS-Fi1

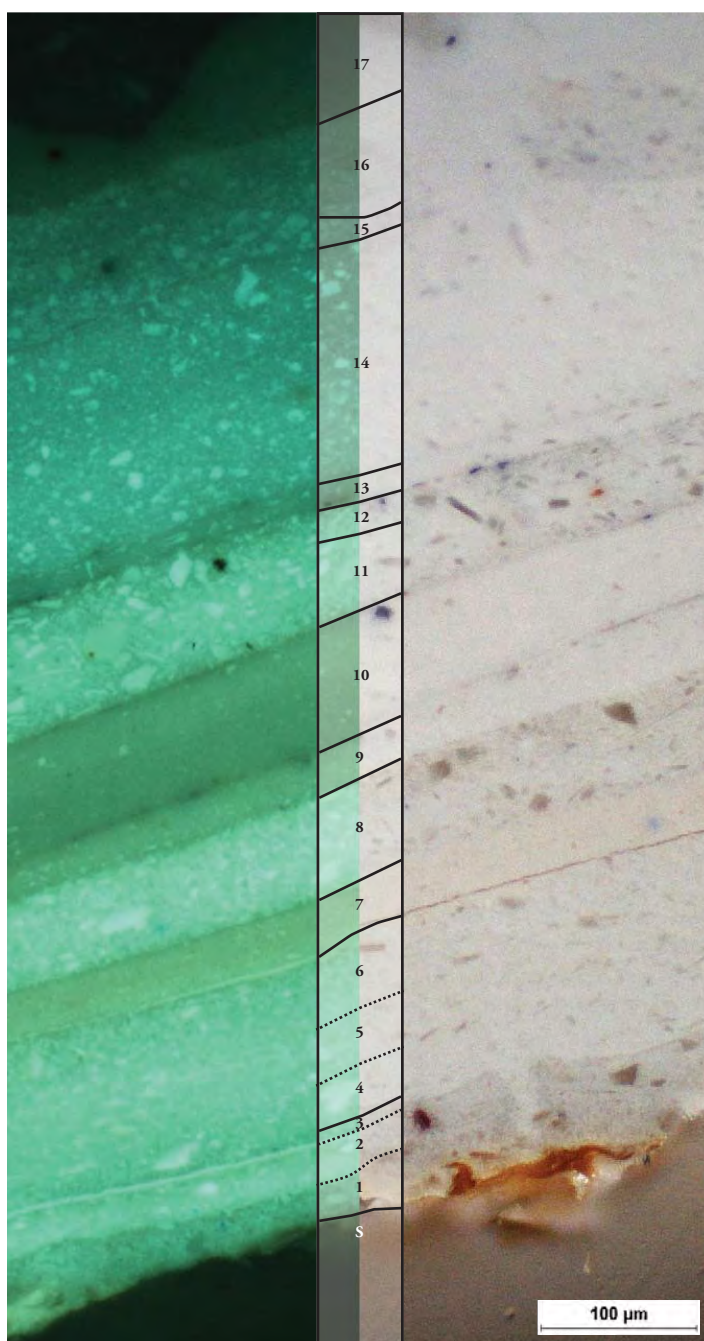
3 Ashford Street

Sample Number: 3 :F: 7	Element: door	Date Sampled: 02/12/11
Sample Location: shutter		Date Analyzed: 04/06/11
Substrate: wood	Illumination: Fluorescence BV 1A, Reflected/Quartz Halogen	
Microscope: Nikon ALPHAPHOT2-YS2		Objective: 10x
Analysis Performed by: Betty Prime		Camera: Nikon DS-Fi1

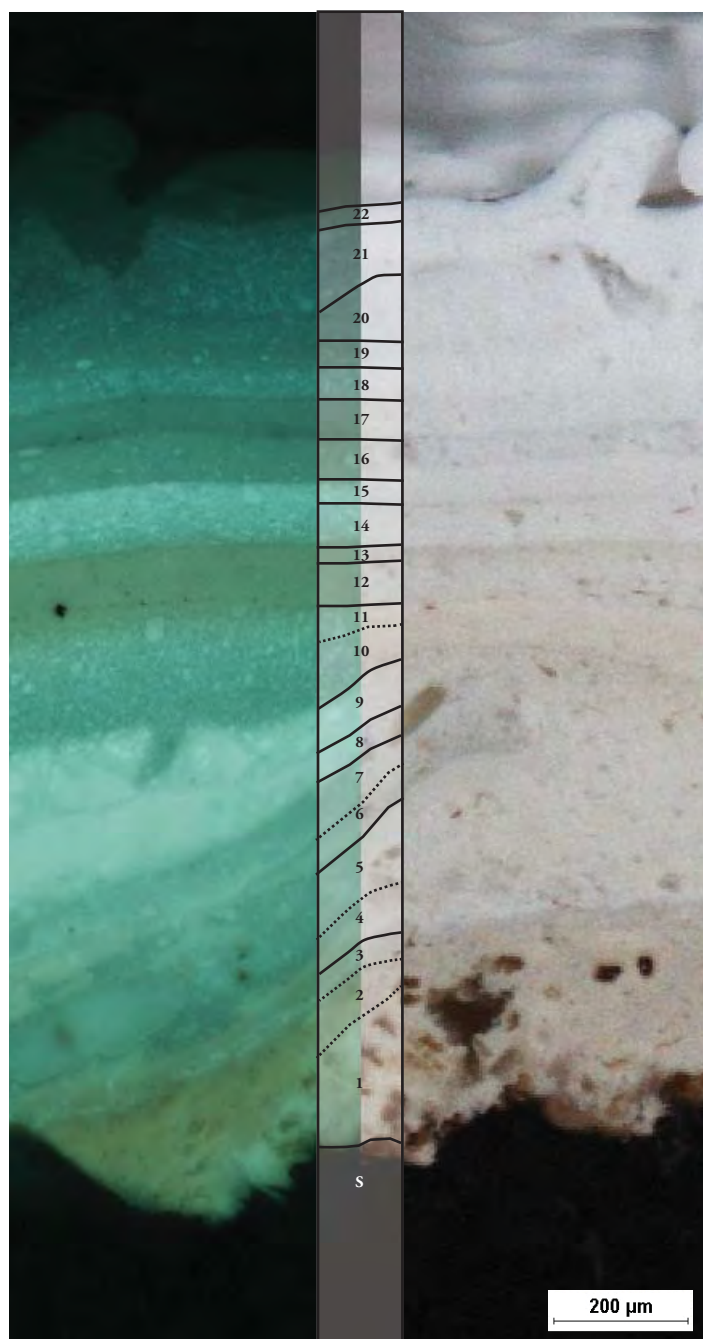
3 Ashford Street

Sample Number: 3 :F: 3	Element: door	Date Sampled: 02/12/11
Sample Location: stile		Date Analyzed: 04/06/11
Substrate: wood	Illumination: Fluorescence BV 1A, Reflected/Quartz Halogen	
Microscope: Nikon ALPHAPHOT2-YS2		Objective: 4x
Analysis Performed by: Betty Prime		Camera: Nikon DS-Fi1

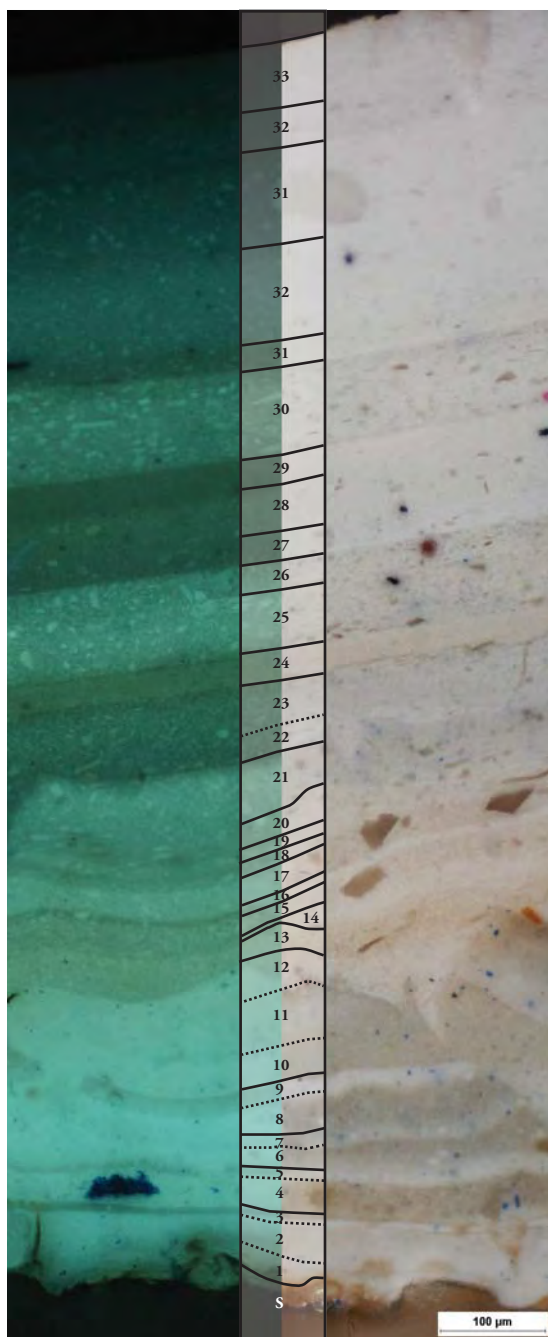
3 Ashford Street

Sample Number: 3 :G: 1	Element: door frame	Date Sampled: 02/12/11
Sample Location: south, left side top		Date Analyzed: 04/06/11
Substrate: wood	Illumination: Fluorescence BV 1A, Reflected/Quartz Halogen	
Microscope: Nikon ALPHAPHOT2-YS2		Objective: 10x
Analysis Performed by: Betty Prime		Camera: Nikon DS-Fi1
